**2nd Year Student Group Project for Research Methods in Physical
Geography (GEOG25020)**

The Avon Partner Project 2018

**Project carried out in partnership with the Malago Valley Conservation
Group**

A Benchmark Study on the Malago River's Water Quality

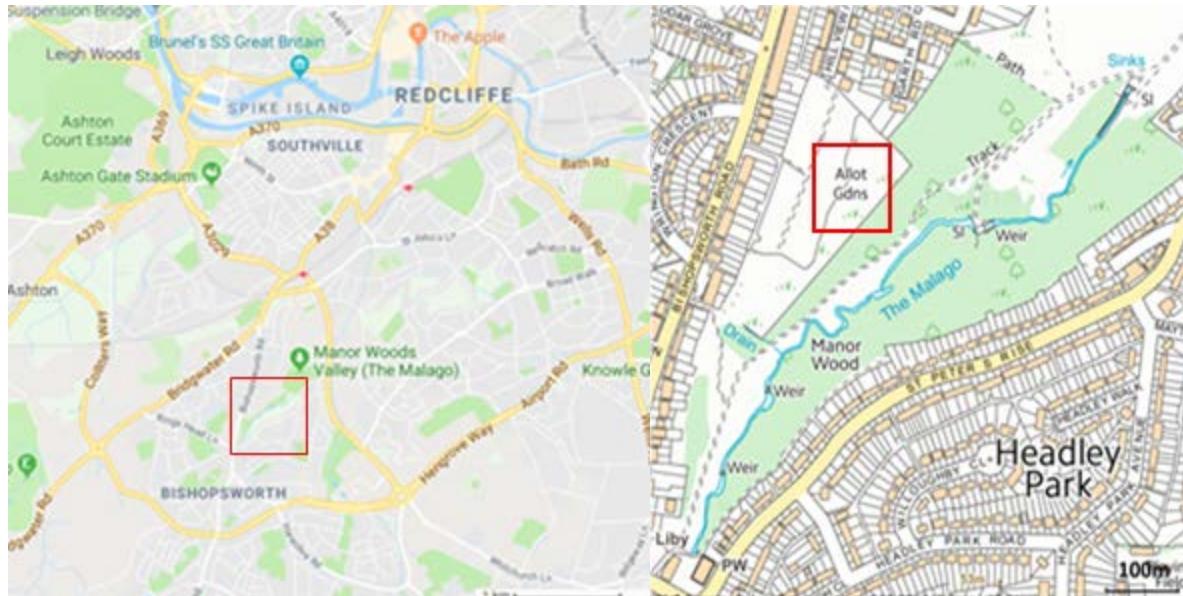
Figure 1: a) The Malago's location in south west Bristol, highlighted in red (Google Maps, 2018). b) The 800m stretch of river, with the allotments, highlighted in red (DigiMap, 2018).

The studied river is an 800m stretch of the Malago River, situated in Manor Woods Valley Conservation Park, Bishopsworth, approximately 2.5 miles south-west of Bristol city centre (figure 1a). The river is immediately surrounded by vegetation and parkland yet resides in an urbanised suburb (figure 1b). The river first flows out of a tunnel beneath a road, and the downstream end flows underground into a culvert, in front of which debris and litter had accumulated. Located approximately half way down the reach are allotments (figure 1b), with large open grassland beyond. A dam, roughly 7m wide and 1.5m tall, features at two thirds of the distance down the river, along with two smaller weirs at approximately 90m and 190m downstream respectively.

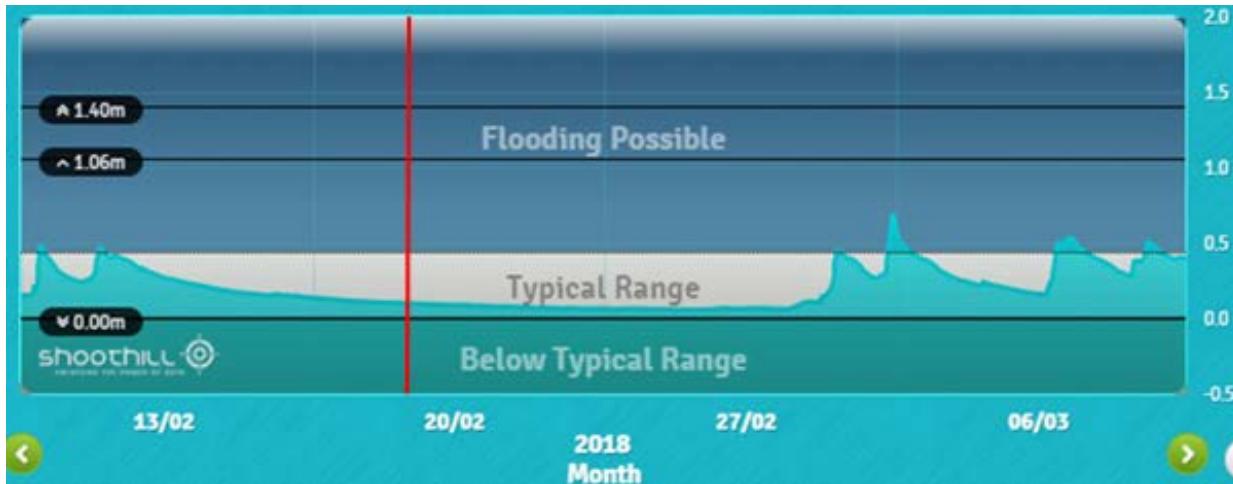
Figure 16: Colliters Brook gauging station, the nearest gauging station to the Malago, showing no significant rainfall inputs in the days preceding 19th February 2018 (Shoothill Gauge Map, 2018).

The nutrient concentrations for the Malago River met the majority of the highest Environment Agency (2011) standards, showing that the Malago River's water quality is very good. However, the low recorded nutrient concentrations must be examined with caution. There had been no rainfall events at Colliters Brook gauging station, approximately 1.5 miles away from the Malago River, in the days prior to data collection (figure 16), and so as a result there was limited runoff from the surrounding land. An assumption must be made here that the Malago River responds to rainfall in a similar way to the river at Colliters Brook gauging station and that rainfall events are also similar due to their close proximity.
