THE MALAGO

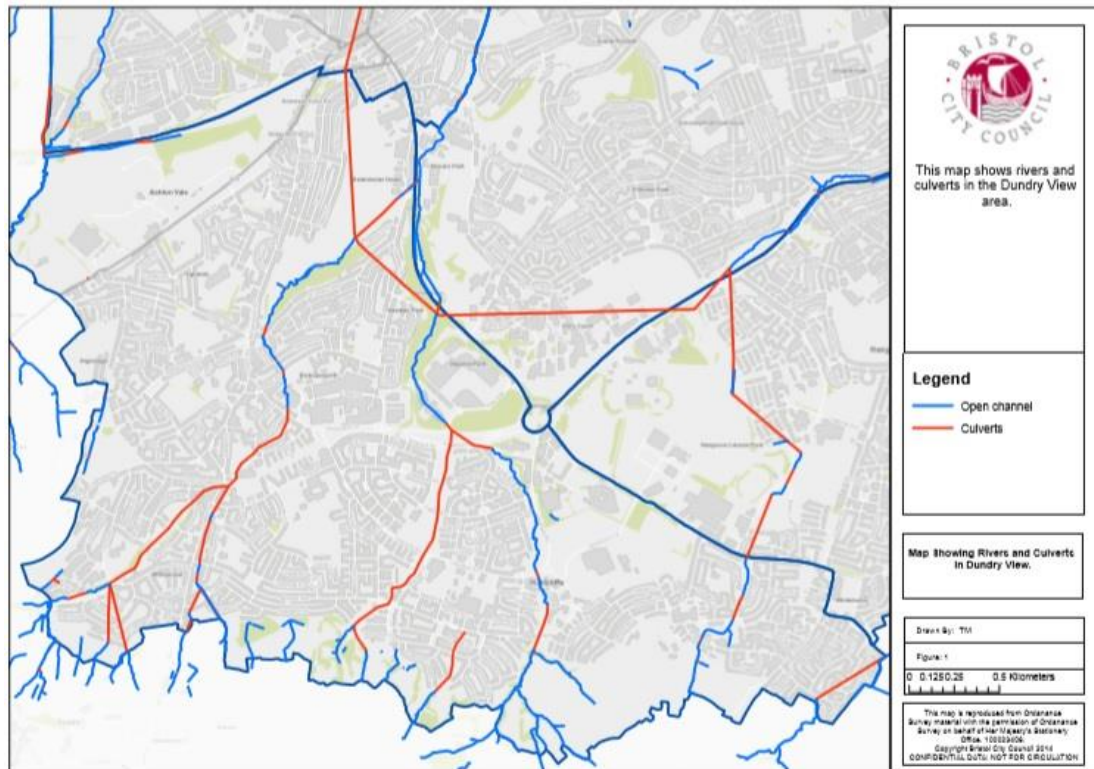
Plan of the culvert system in South Bristol (blue – open water, red- culverts)

As part of the flood defence system, a massive culvert circuit was constructed around a good part of South Bristol. This intercepted all of the Malago's water from half way along its course through Manor Woods Valley, diverting it down a 3.25m wide tunnel. This culvert discharges in to the New Cut in Southville, just upstream of the junction of Coronation Road and Calvert Road. Some Bristol residents recall the sounds of the underground workings beneath their houses during the construction works that lasted from 1971 to 1974.

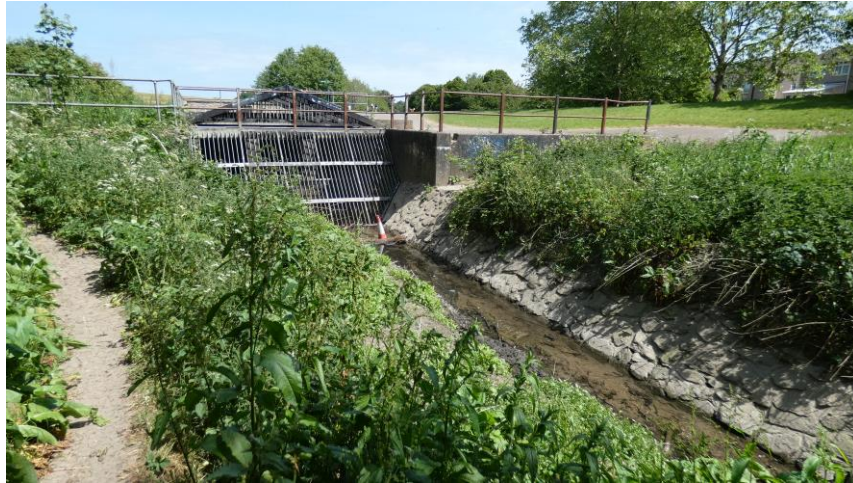
The Interceptor – where the Malago disappears underground in Manor Woods Valley

The interceptor was officially opened in 1976. Now, only a small amount of local drainage water leaves Manor Woods Valley at its northeast end, where it joins water from the Pigeon House Stream on the west side of Hartcliffe Way. This water eventually enters the New Cut though Victorian culverts at Bathurst Basin. The lack of a continuity of the watercourse within Manor Woods Valley means that the upper reach of the Malago is effectively ecologically isolated from the lower reach.

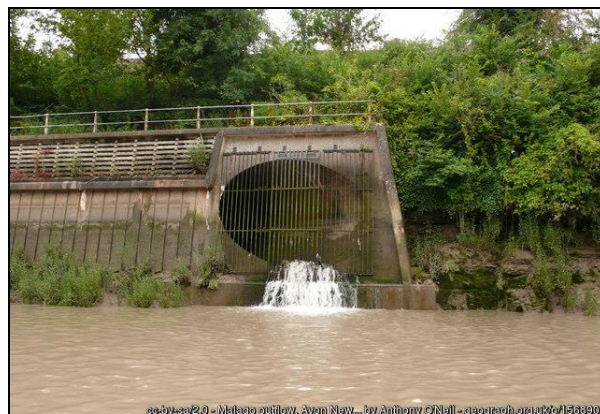
The interceptor culvert outfall in the New Cut

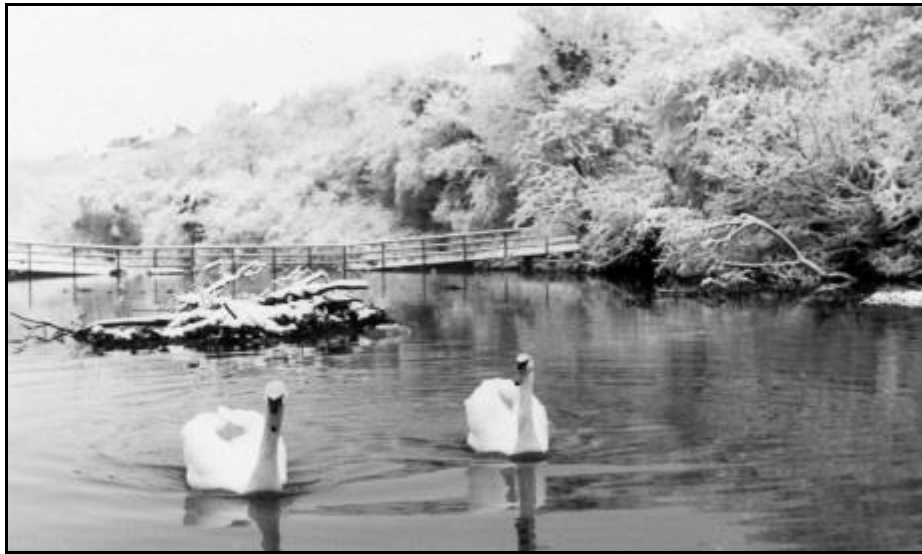
The dam and silt trap in Manor Woods Valley in 1981

Associated works involved the canalisation of part of the Malago upstream of the interceptor and the construction of a dam to form a silt trap pond.

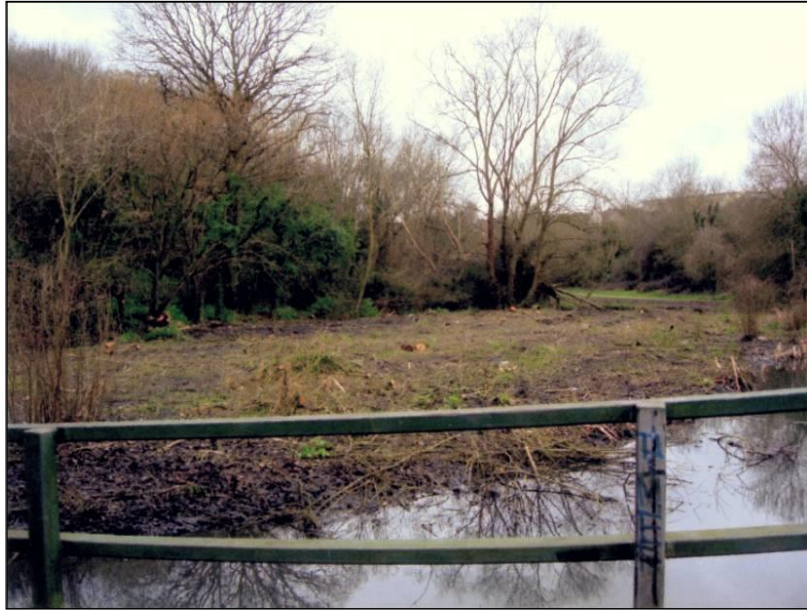
2010 – the silted-up pond cleared of scrub Willows

In anticipation of de-silting of the pond, BCC cleared the developing Crack Willow scrub from the area during the winter of 2009-2010; however, the de-silting did not occur and instead the Willow was left to re-grow into the coppice woodland that we see today.

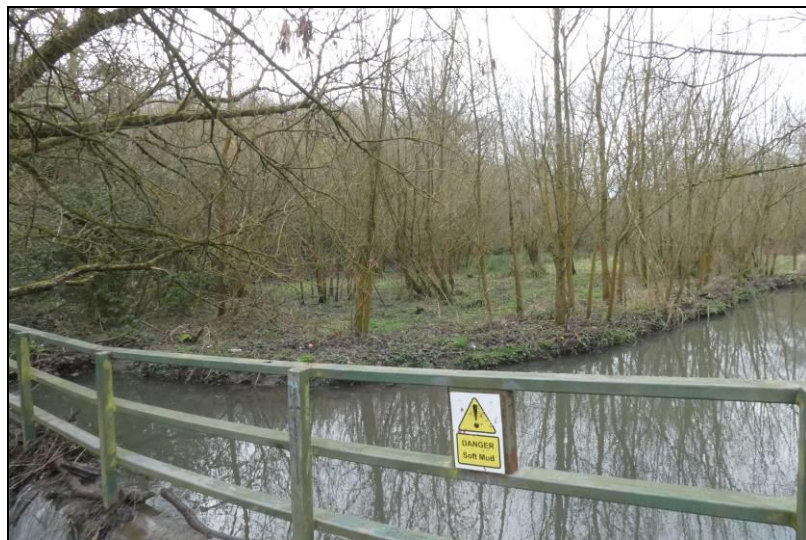
The 'Pond' in 2019 - now willow carr dominated 'Pond Wood'

De-silting the pond has been suggested on several occasions since 2010, however the areas either side of the Malago where the pond once was, are the only largely undisturbed areas on the site. There are no paths through them and dogs rarely if ever enter them. These are the only areas where Mallards and Moorhens can reasonably safely nest.

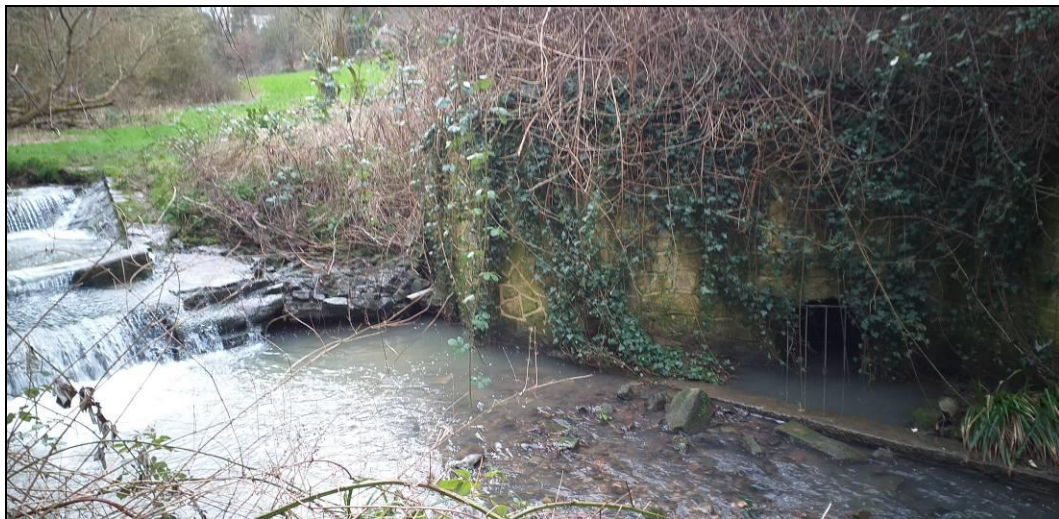
The CSO on the Malago in Manor Woods Valley

As a result of the work by Bristol University Students and increasing public awareness of inland water quality issues, in 2020 MWVG started to take a particular interest in the water quality of the Malago. It soon became clear that there are four Combined Sewage Outfalls (CSO's) upstream of Manor woods Valley, and one within it. The latter is situated immediately downstream of the Lower Stepping Stones.

CSO's discharge untreated sewage and waste-water when the sewerage system is overloaded during periods of intense rainfall. Without CSOs, sewage could back-up in to houses and gardens. As CSOs should only operate during periods of unusually intense rainfall. Foul water released from them is very dilute because of the large volumes of rainwater within the system. Flows are further diluted by the receiving watercourses that will

also be swollen by the same heavy rain. CSOs are fitted with screens that help remove debris from the flow and minimise any environmental impact.

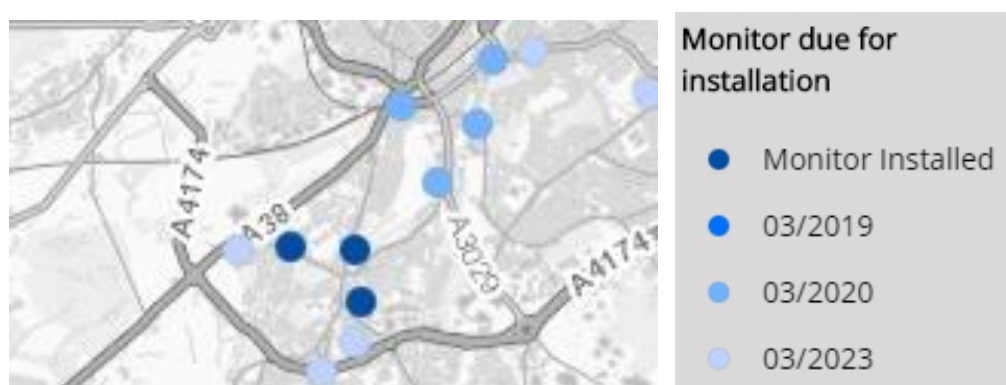
CSO monitoring points in the vicinity of Manor Woods Valley

Bacteria are common single-celled organisms and are a natural component of lakes, rivers, and streams. *Escherichia coli* (abbreviated as *E. coli*) are bacteria found in the environment, foods, and intestines of people and animals. Although most strains of *E. coli* are harmless, others can cause illness. *E-coli* counts from monthly monitoring of the Malago in Manor Woods Valley, conducted by Bristol City Council (2018), suggested that on numerous occasions in the previous thirteen years; counts exceeded the Environment Agency's recommended 10,000 counts/litre. Results from monitors that are being installed on the CSO's, indicate that there were thirteen discharges from at least one of CSO's upstream of Manor Woods Valley during 2018, and nine and eight discharges respectively in 2017 and 2018 from the CSO with the site.
